Big V—SeaCanvas IIc

Powerboat - Soft Enclosures

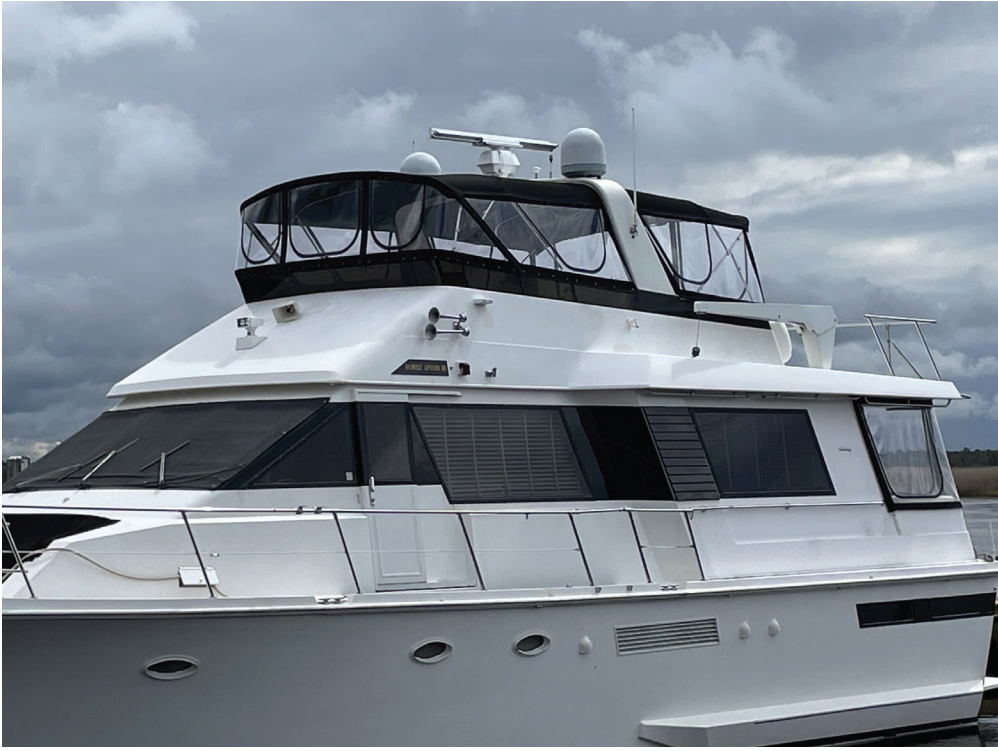
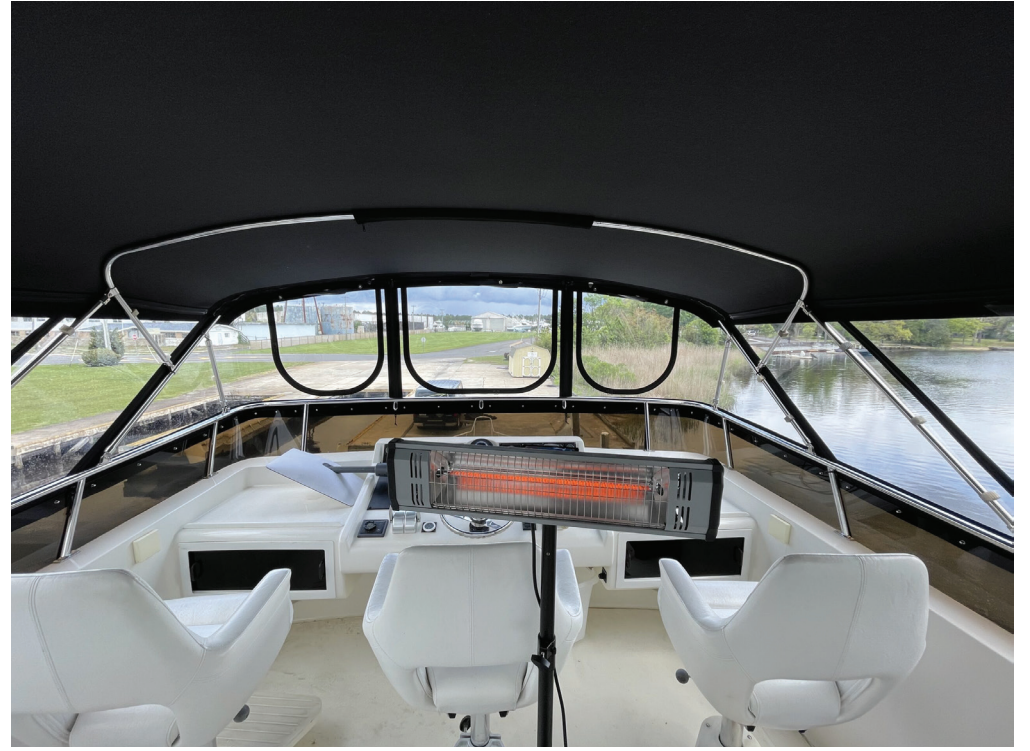
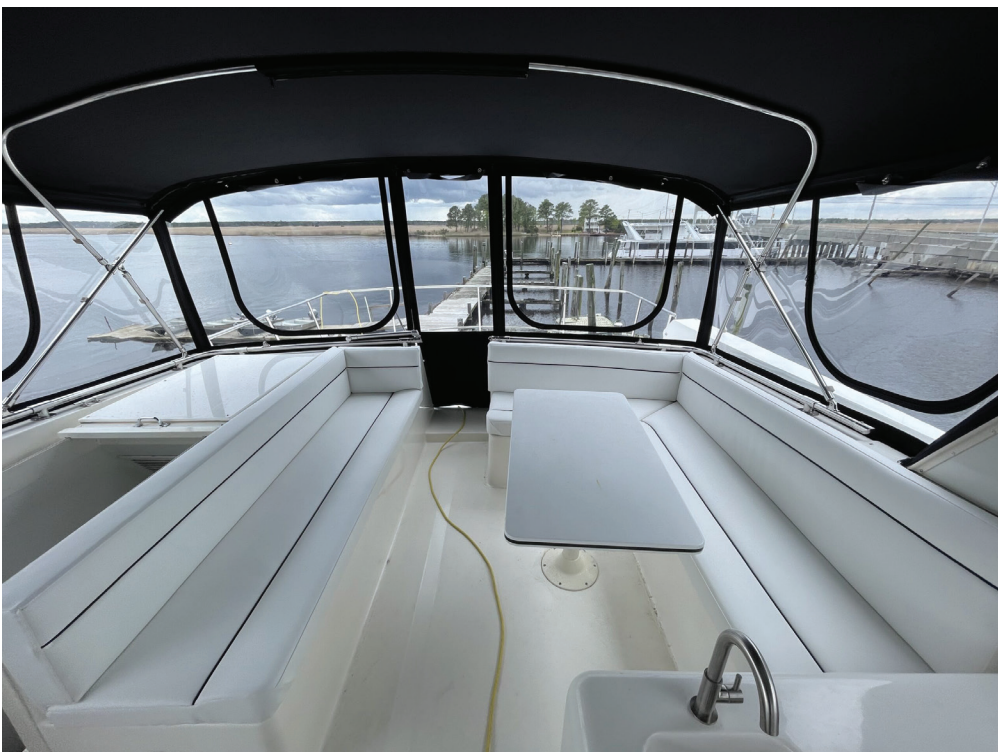
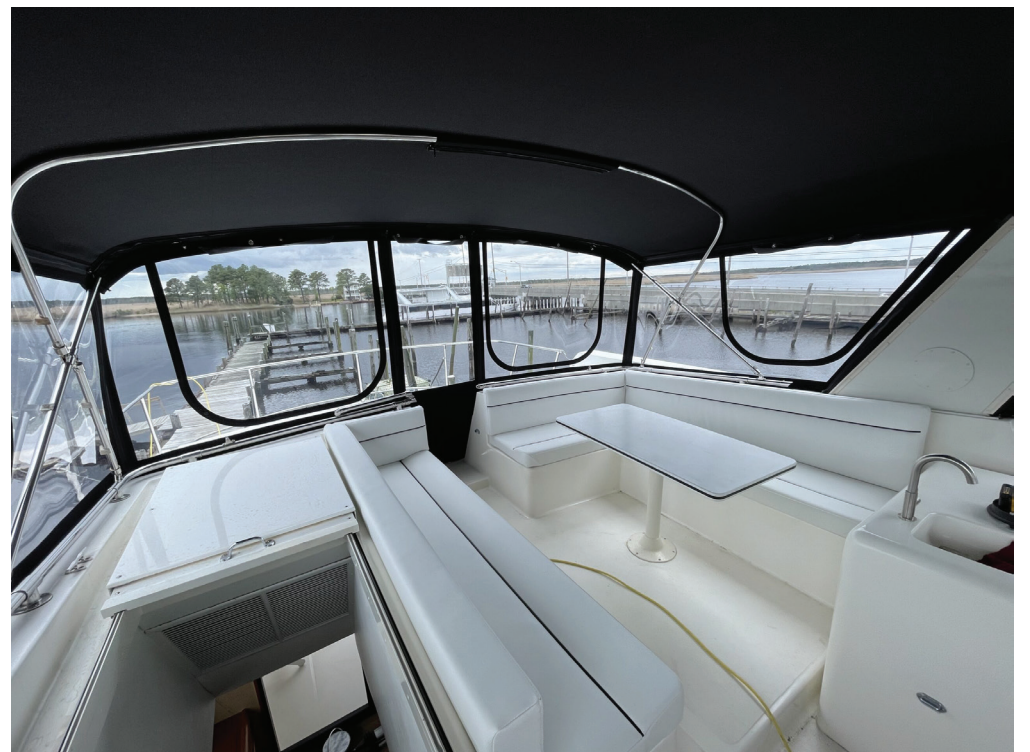
Fabricate a full bridge enclosure on this Viking Motor Yacht, Use of existing frames we fabricated 2 large biminis attached to the mid arch. Snap line around perimeter forward of the arch and track at base aft of the arch. Client's interest was to update the existing enclosure.

The size of this complete enclosure is huge. This Viking 55' equals 2 large bimini's and large Crystal Clear .040 windows. Customer wanted this install in early May so the use of heaters while setting snap line was needed. We did get the temperature up to 65 degrees on a low 50's degree day. We were pleased when we saw this vessel again in the warm summer months.

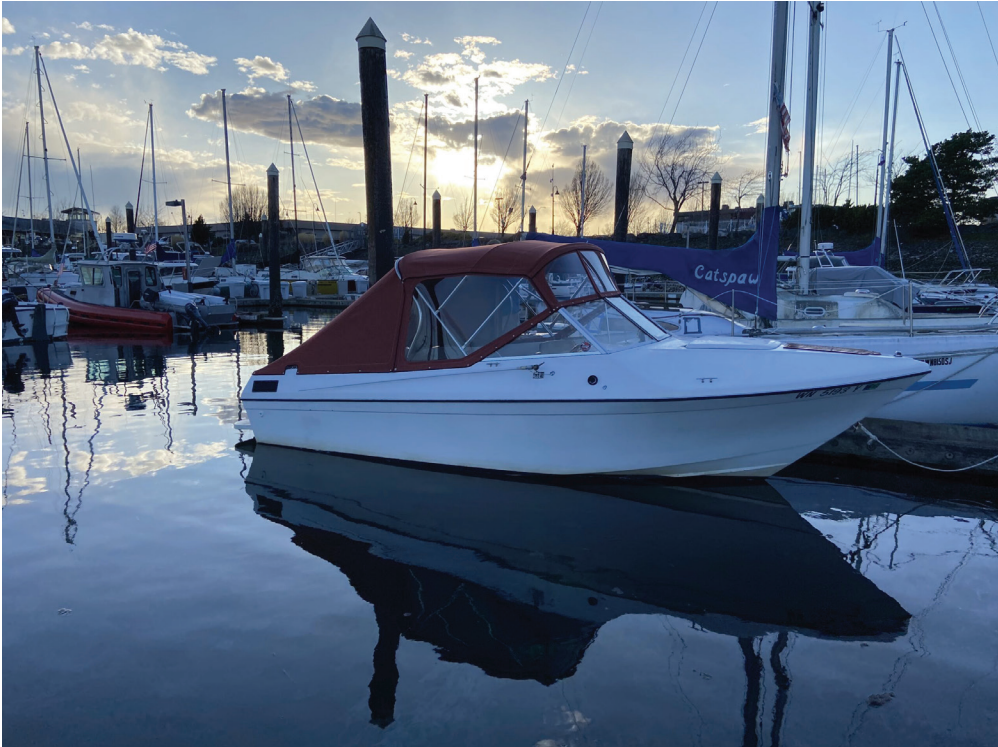
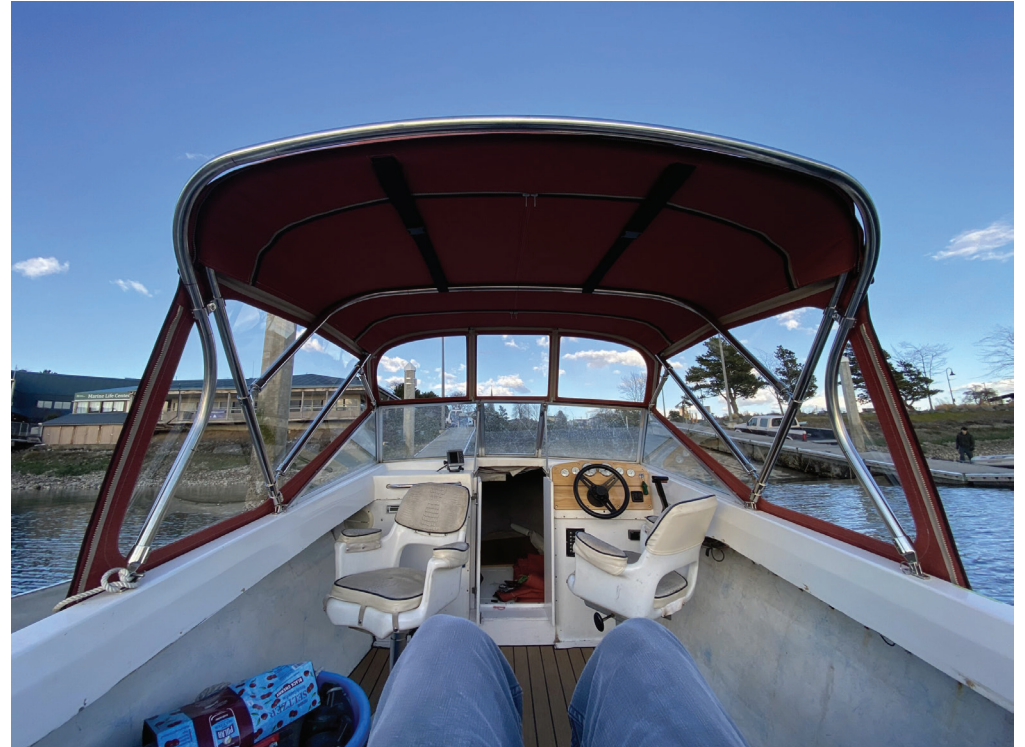
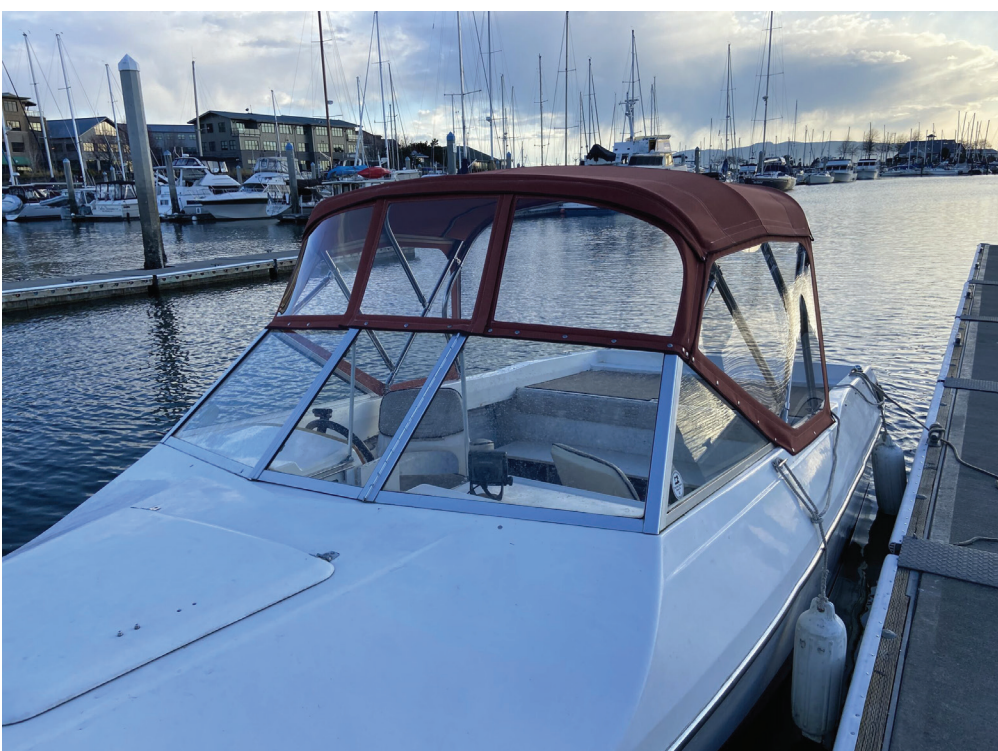
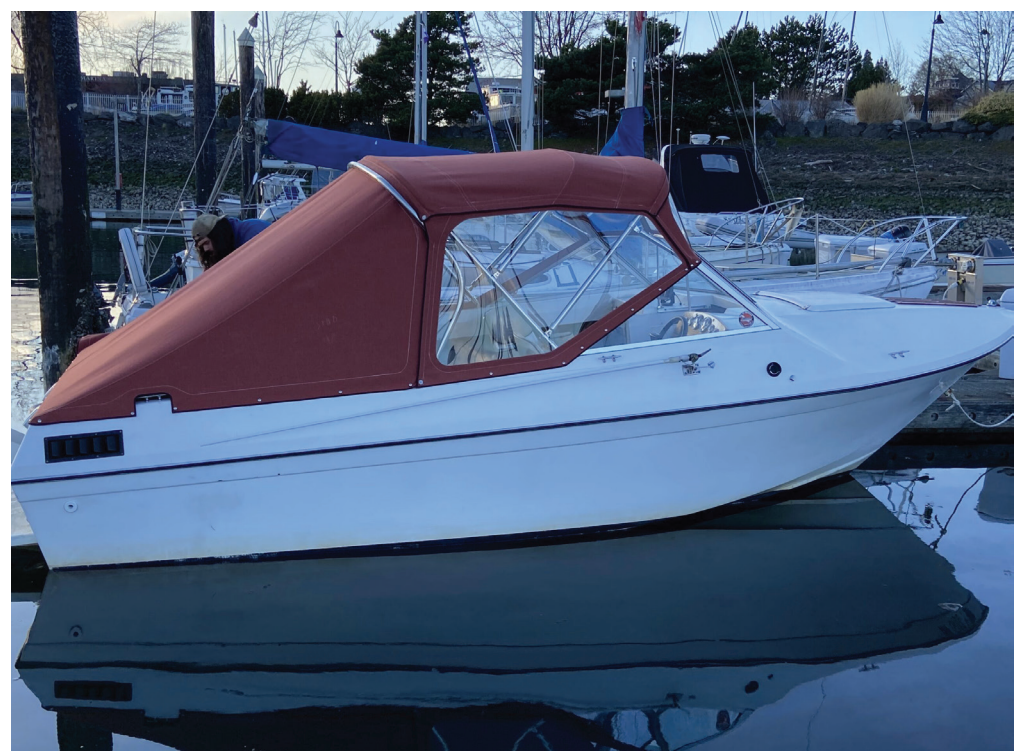
Salish Sea Apollo—Oyster Creek Canvas

The client wanted a super strong top with a slant back on his restored 1974 Apollo. He wanted to have a grab handle on the aft bow and have the top be really tight for bombing around in the San Juan Islands in Washington State and the Gulf Islands in British Columbia.

I think that the frame design is unique with the aft grab handle being both the hard leg support and the grab handle. We used 1.25" tubing which also made it stand out compared to other frames commonly found on boats of this type and size. I also like the new Sunbrella color as we had never used that for a project before!

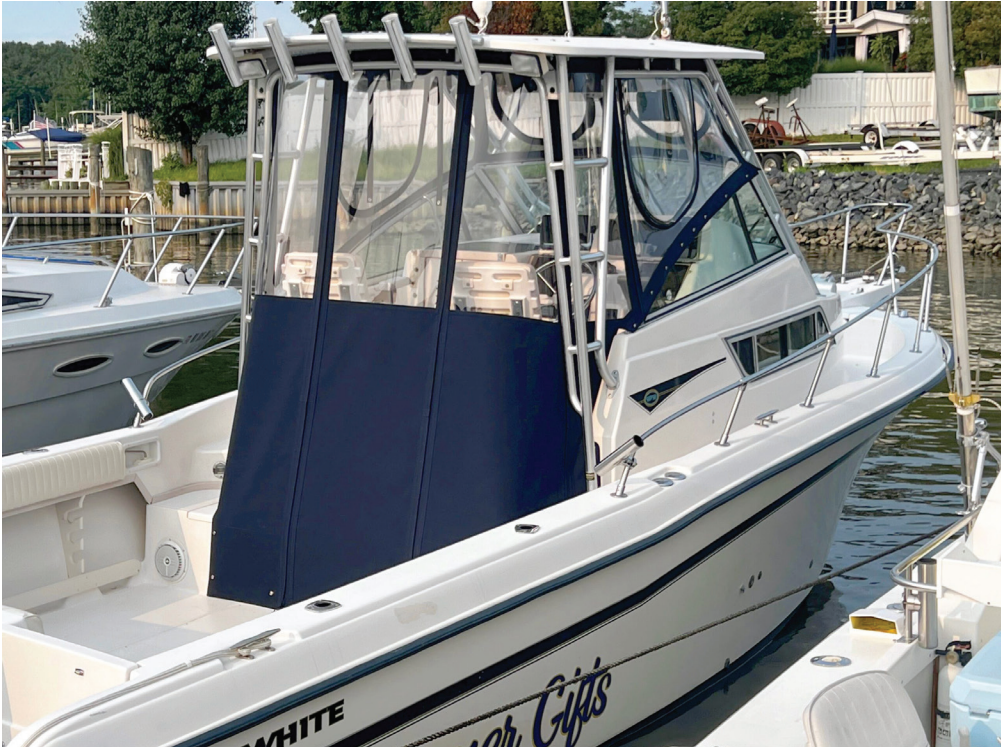
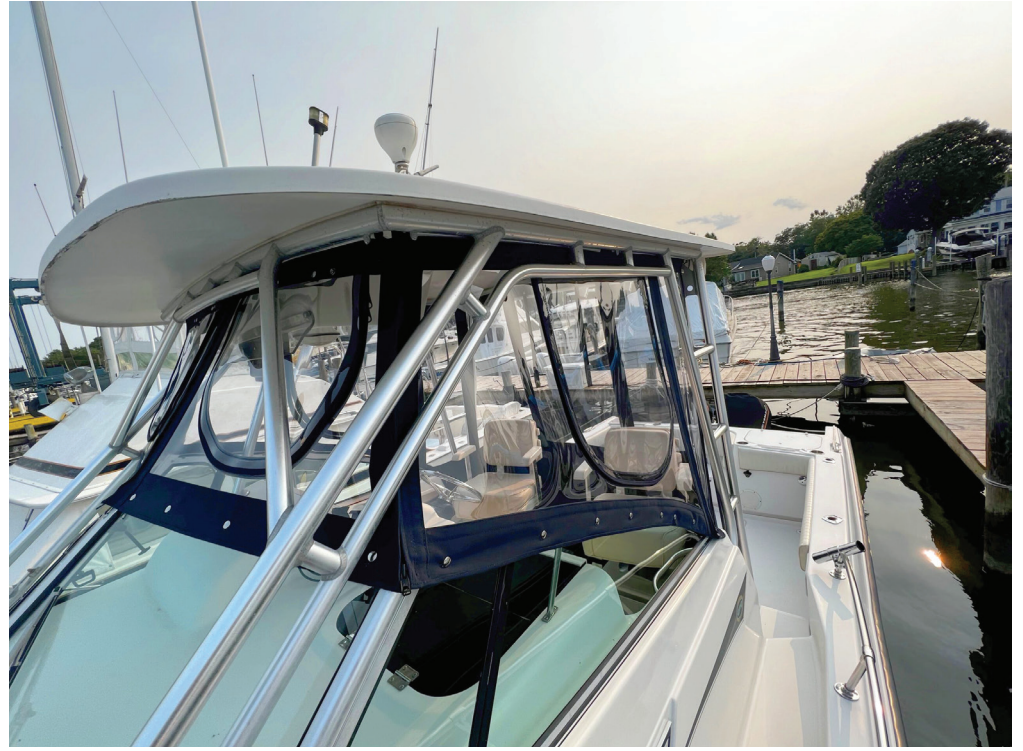
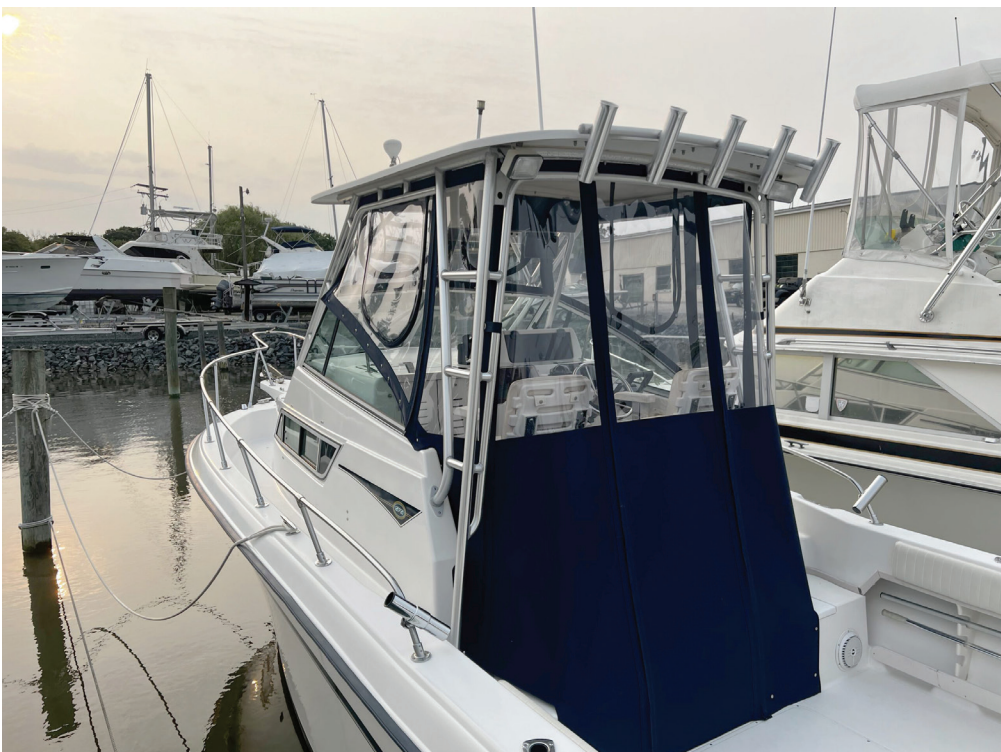
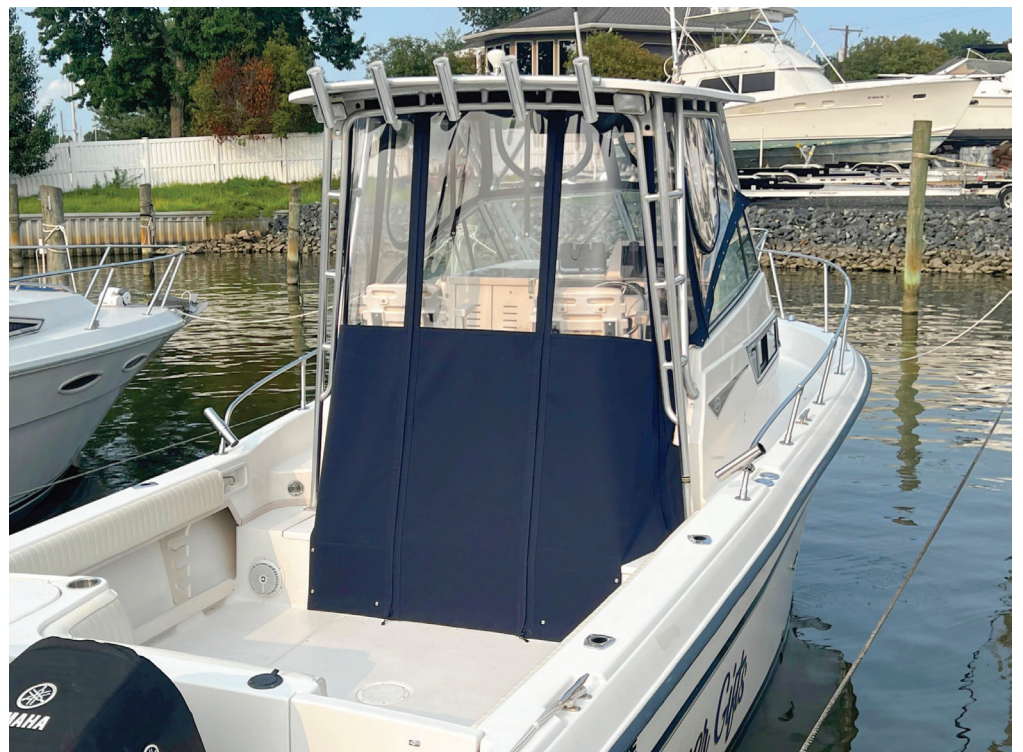
Grady White Delight—Top Stitch Marine Canvas

The client requested a new enclosure to replace the existing one. He asked if the side u-zip windows could be moved further back to be easier to roll up from the helm. This was a fully digital project that we scanned using our ProLiner, and then rendered the design in Rhino CAD. Once the design was created, we cut the fabric and the Strataglass on our cutting table. Everything was assembled, then installed on the boat. We were extremely pleased to see how this project turned out, especially since it was only our third digital project.

We entered this project because we were very pleased with the fit and design, especially since it was only our third digital project. It's hard to tell from the pictures, but the front part of the hardtop frame actually pushes into the plane of the front enclosure window panels, making it a difficult fit to get correct. Fortunately for us, we were able to model it correctly in CAD and achieve the desired result. The client was very happy with his new enclosure!

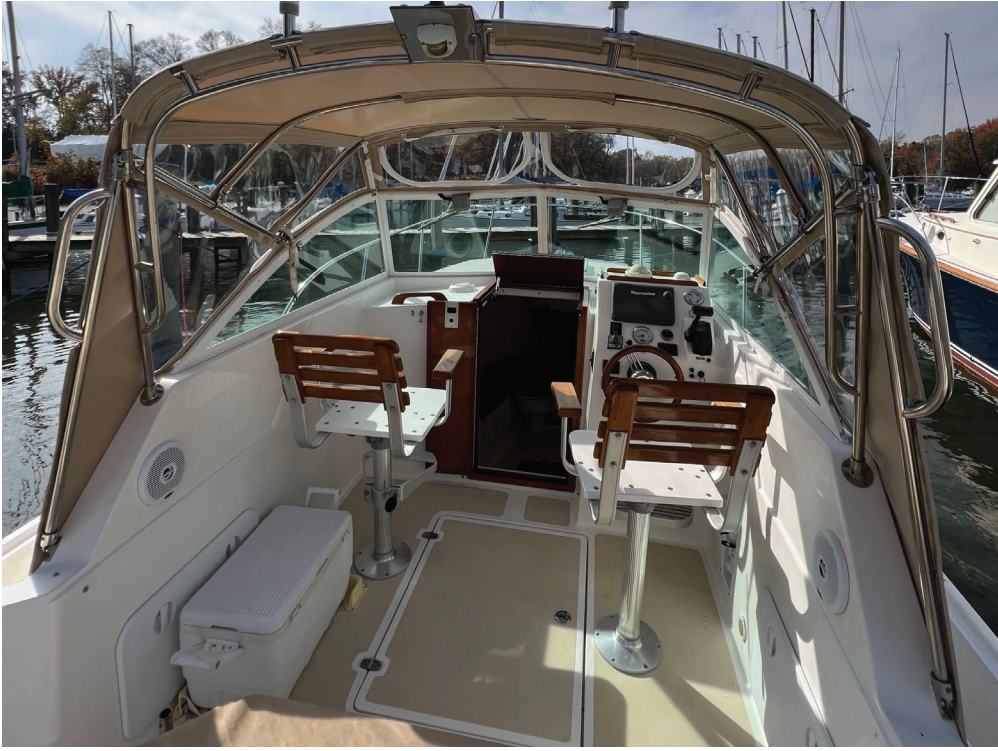
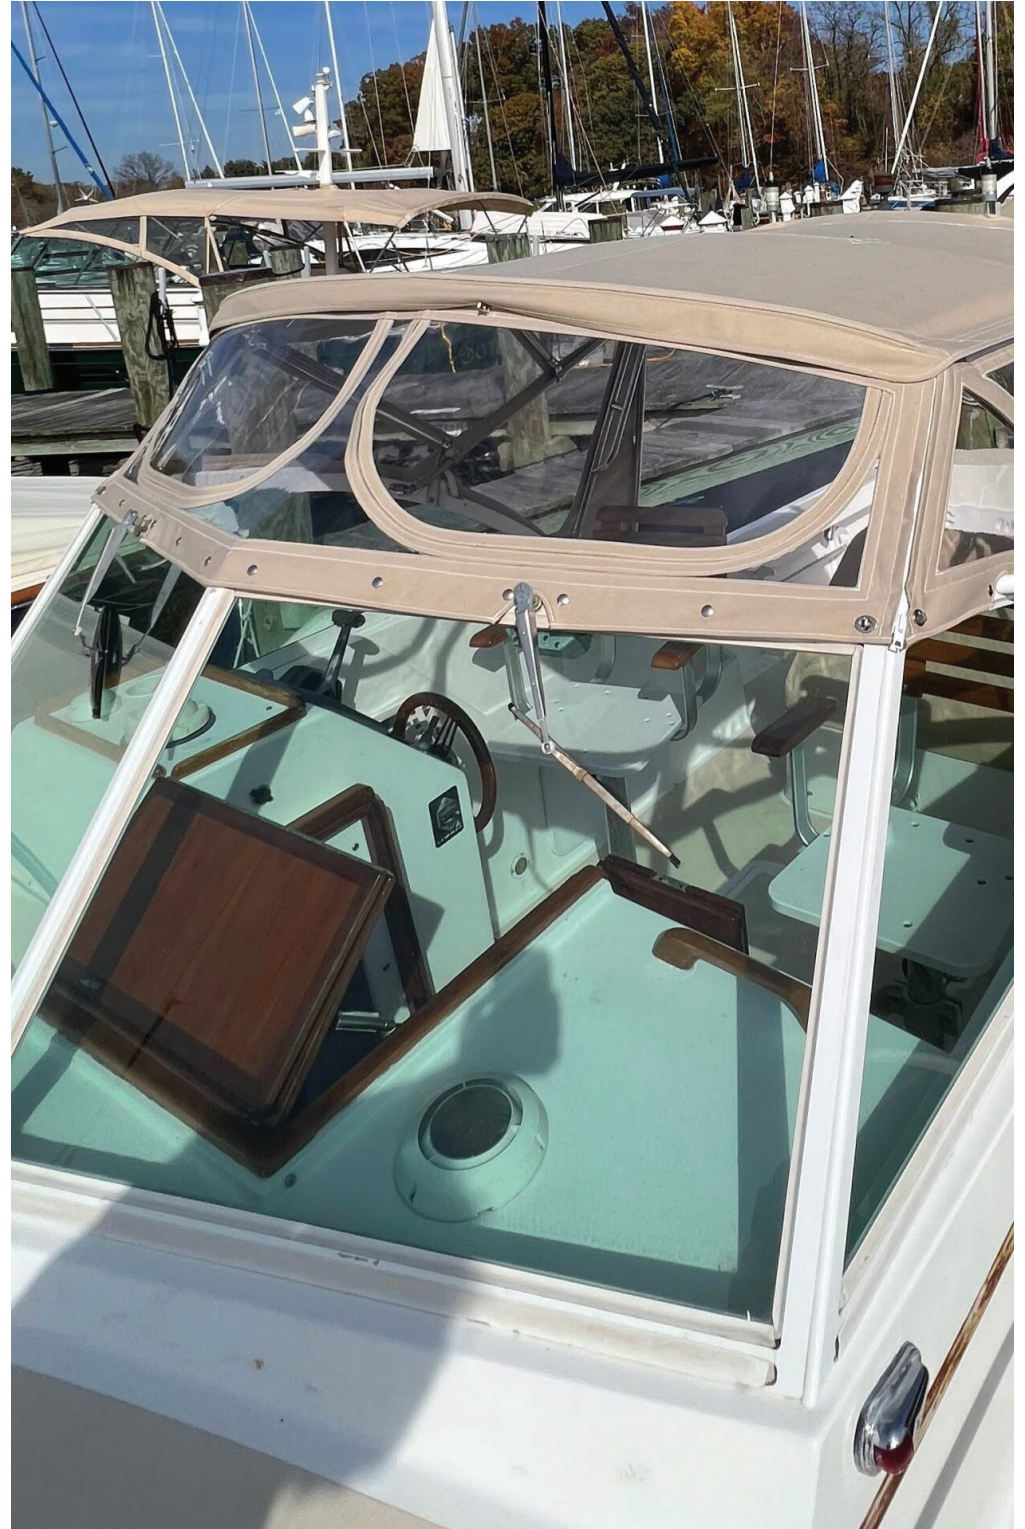
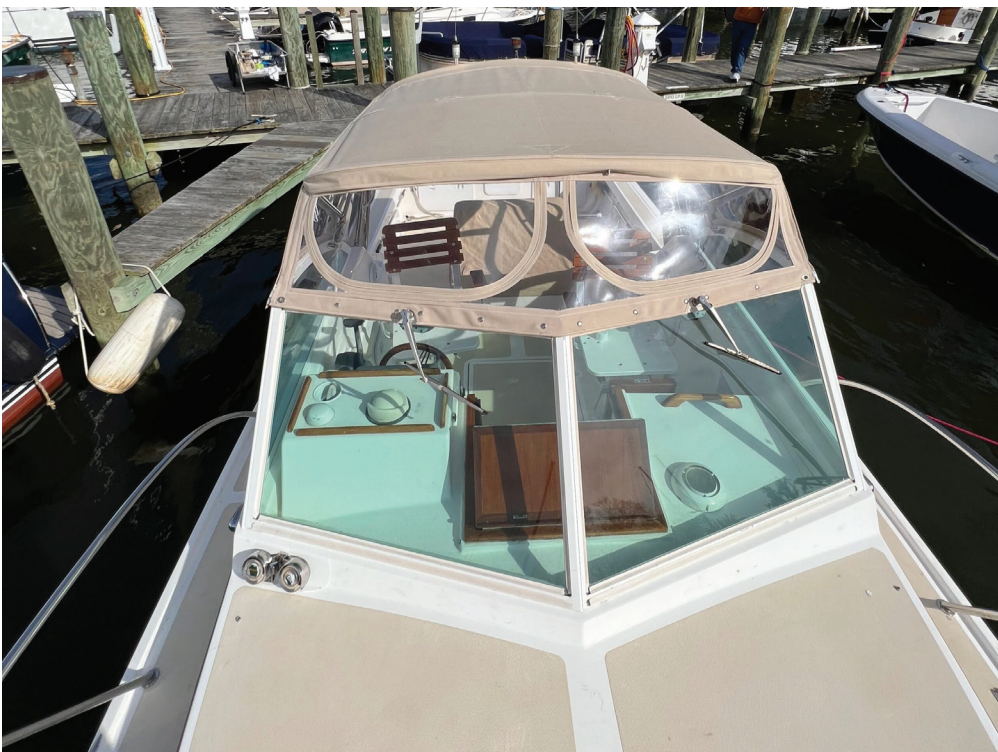
“Sass-Sea” Li'l Thang—Yacht Canvas, Inc.

This vessel was long overdue for a canvas update. While the owner initially desired a recreation “just the same way,” we proposed several improvements. Starting from the top, the previous bimini laced onto the aft bow due to multiple joining points in the arch. To create a cleaner look, we completely wrapped this bow with multiple zippered pockets. This not only provided a few more inches of rain coverage but also enhanced ease of use, allowing the customer to remove the bimini at their convenience without the hassle of retying.

The customer sought ventilation during warm months while underway but also wanted minimal sight disruption. Two U-zips in the single forward windshield addressed both concerns. We finished this forward enclosure with a single panel on each side, incorporating reinforcement strips to protect the clear vinyl from the stainless. This project hit a home run with the customer who was able to enjoy a full season on the water protected from the sun and rain.

We chose this project to enter due to the unique single forward window with double U-zips, and the challenge of the aft arch. Moving this bimini away from a tie on bimini was a challenge we were happy to tackle.

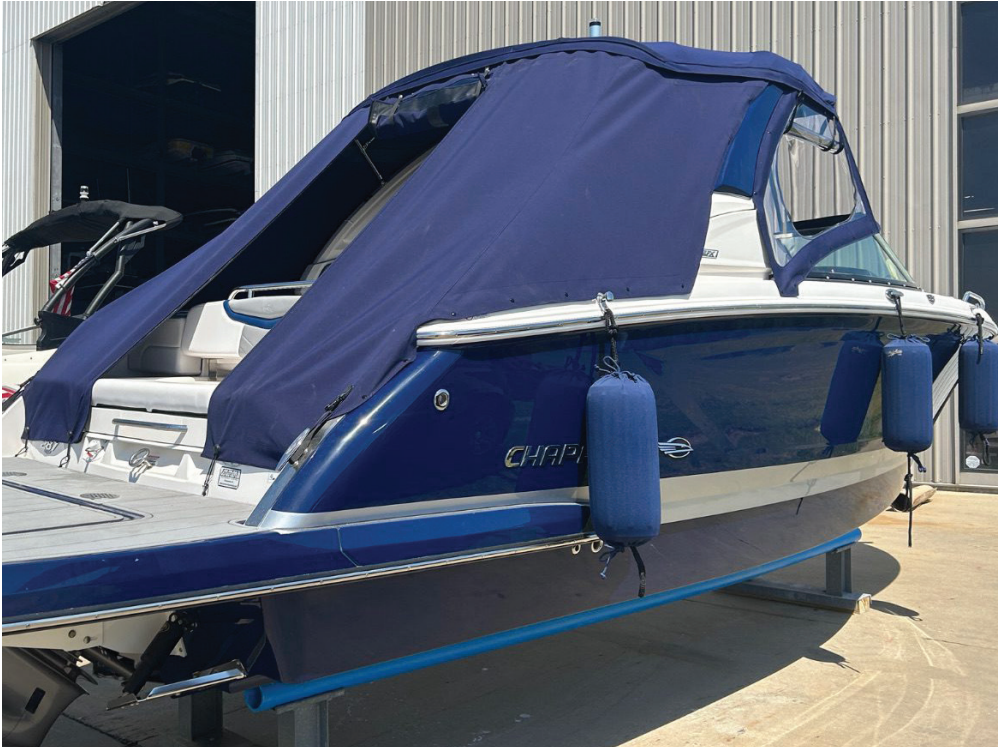
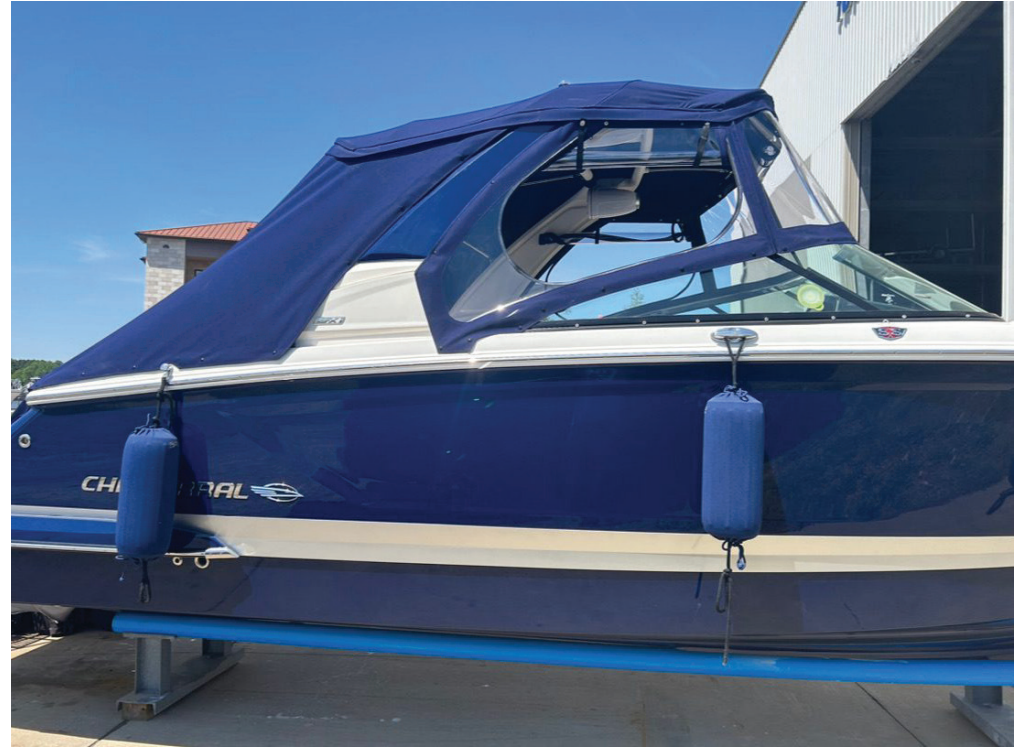
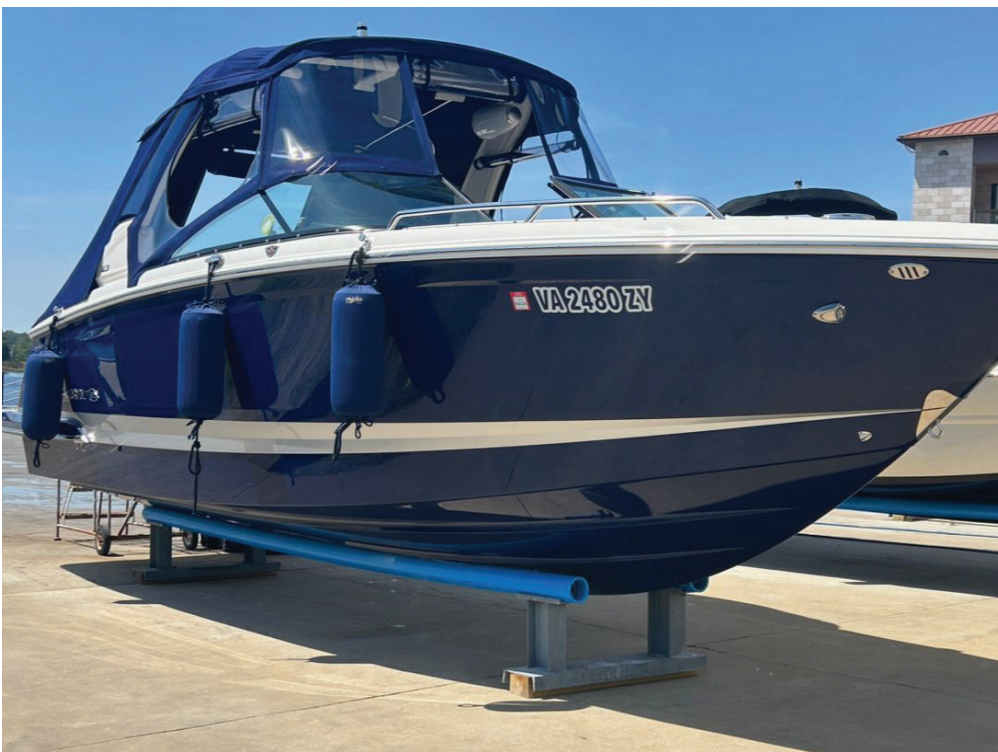
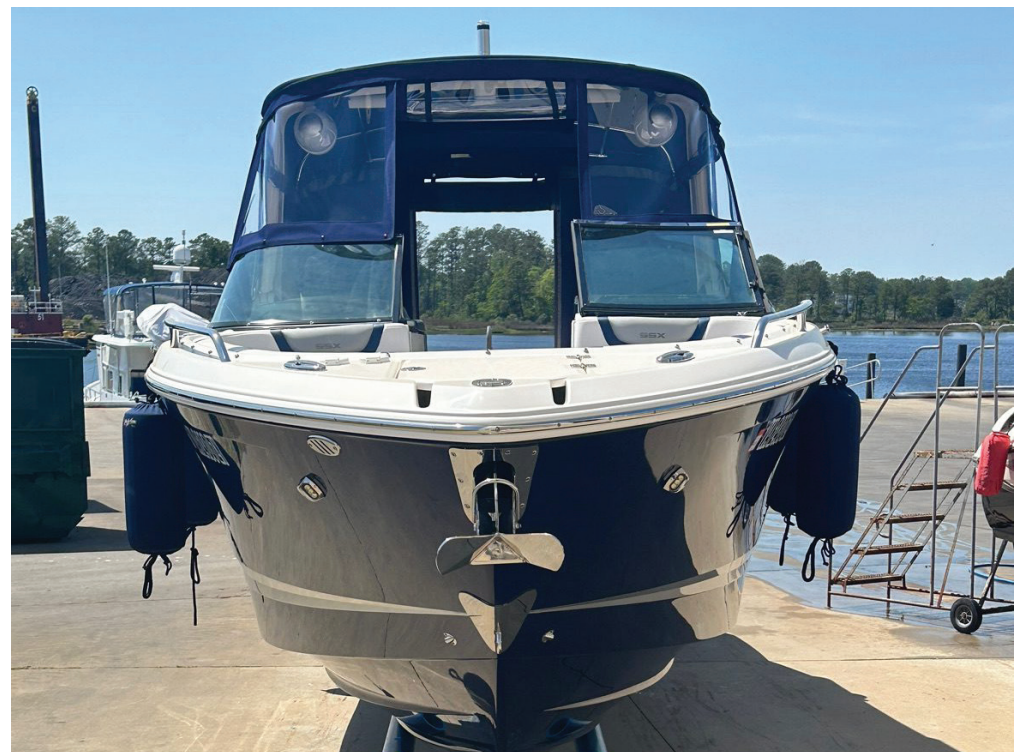
One Slick Chaparral—Mike's Marine Custom Canvas

The customer wanted the ability to have a full enclosure and maintain the slick style of the wakeboard boat. They wanted minimal drilling into the power-folding arch and stainless steel windshield. We installed snaps that wedge between the steel frame and the rubber gasket around the perimeter of the windshield.

Doing a full enclosure on a wakeboard boat is full of unique challenges. Pulling a large enclosure off of a tiny top and being able to store everything easily is a challenge in itself. Also being able to open up the windows for airflow is a unique feature.

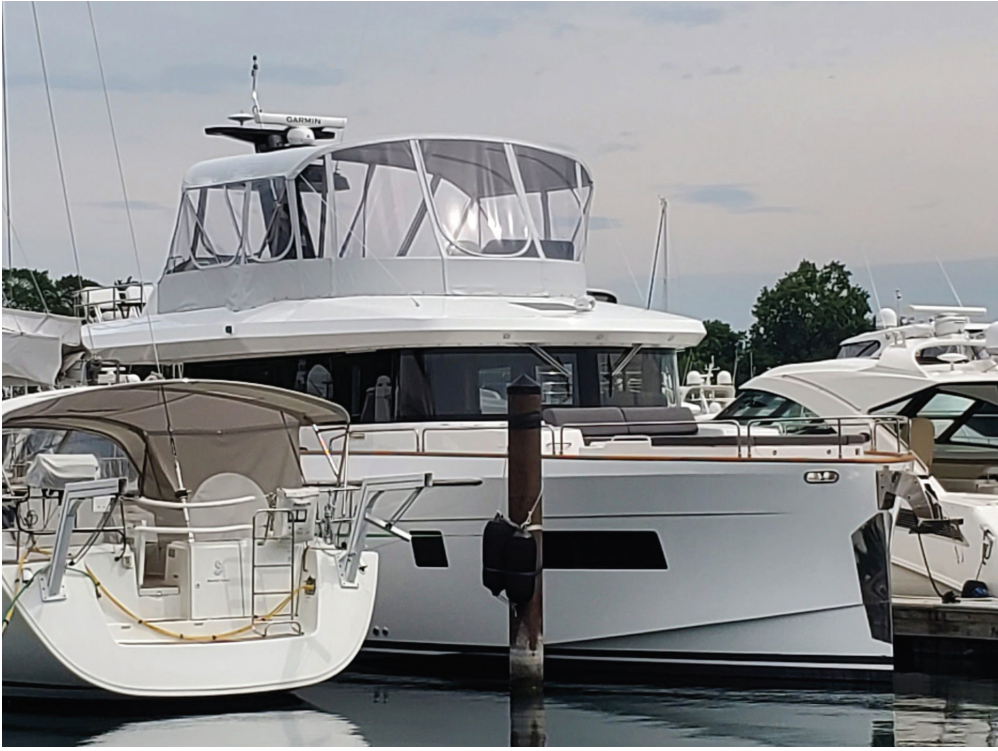
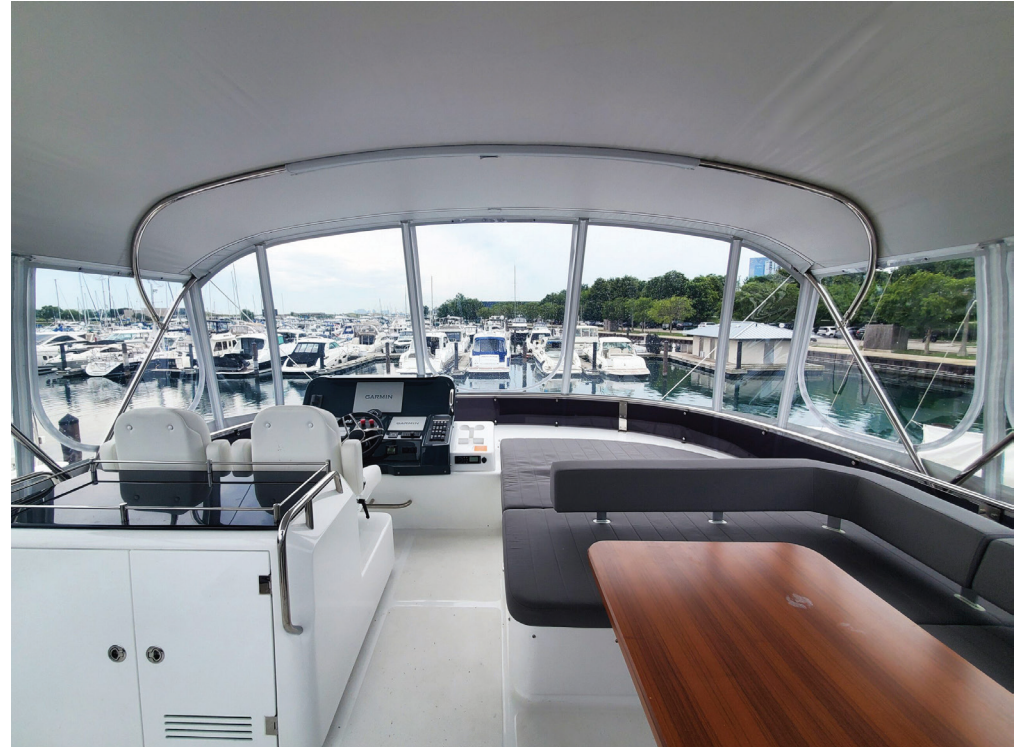
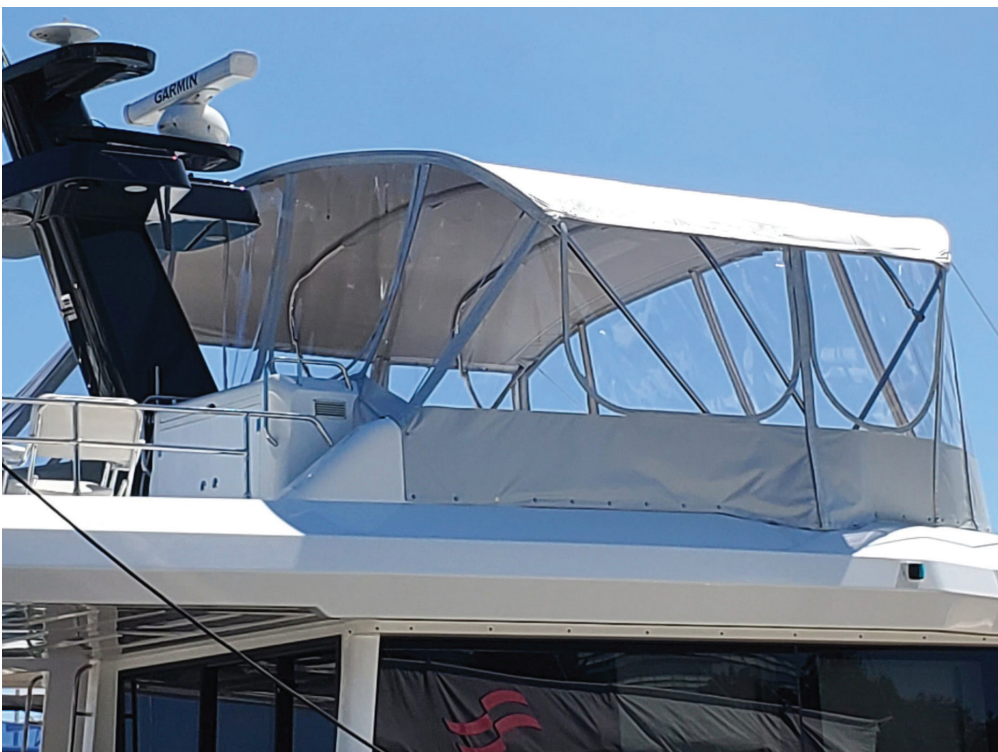
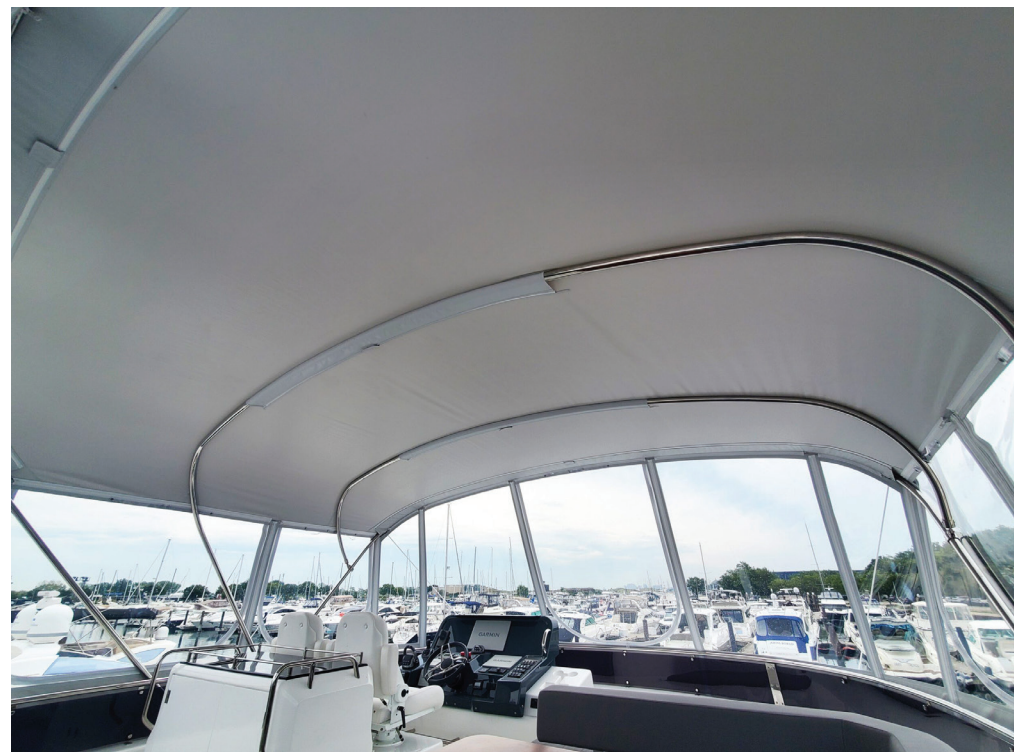
Sirena—Chicago Marine Canvas

The customer purchased a 2023 Sirena 58 Open Flybridge and wanted to add a full enclosure to the flybridge. It would enclose the bridge area and also the stairway to the lower aft area.

The customer purchased a 2023 Sirena 58 Open Flybridge and wanted to add a full enclosure to the flybridge. It would enclose the bridge area including the stairway to the lower aft area. The enclosure was 15 feet wide, 19 feet long and eight feet tall. It was supported by a retractable frame that was fabricated by the yacht manufacturer. The yacht did not have any fasteners installed and the customer wanted the option to remove all of the enclosure panels. We looked at different areas for placement and wanted to conceal them and decided to install CAF Campo white snaps. These blended perfectly with the fiberglass. The bridge was measured with a Prodim Proliner and then designed in CAD software. By using a virtual design process, we were able to look at different ways to build the enclosure. Some of the panels were so large that we had to divide them, such as the front windows which were maxed out at 7 feet long and over 4 feet wide. One item the customer requested was that as many as possible of the windows should feature roll-ups. Typically, we fabricate with 40 gauge Strataglass but since the panels were so large we decided to fabricate with 30 gauge. It was very easy to work with and this maybe the fabrication and installation process 25% easier. The finished enclosure was a huge success and exceeded the client's expectations. They were extremely excited with not only the look of the enclosure but also the ease of use and functionality.

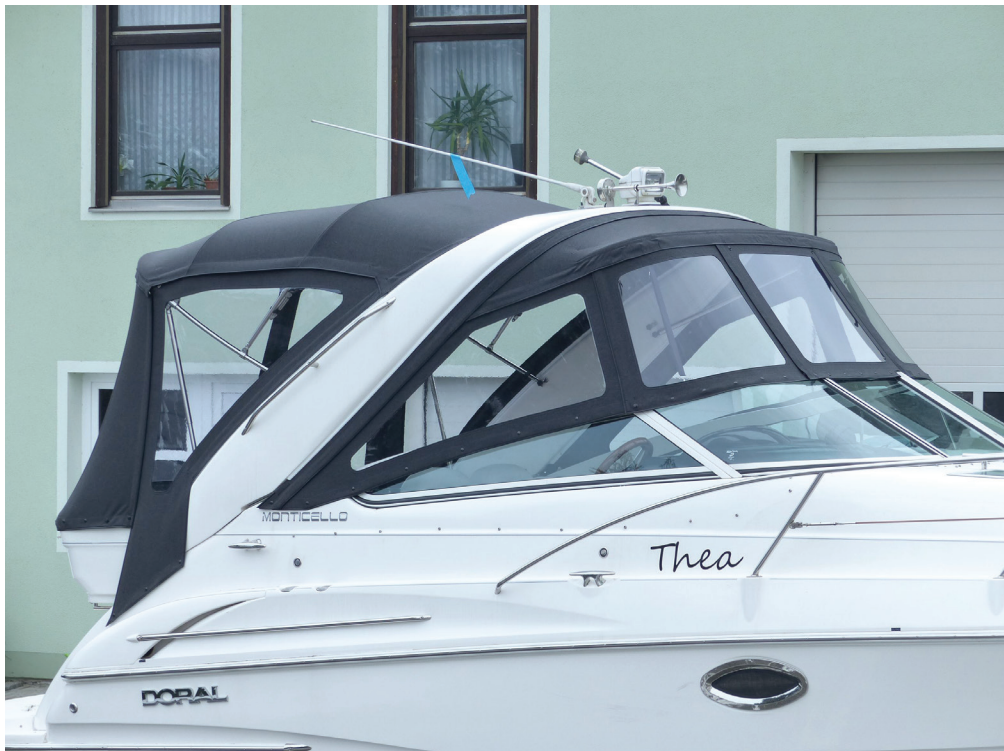
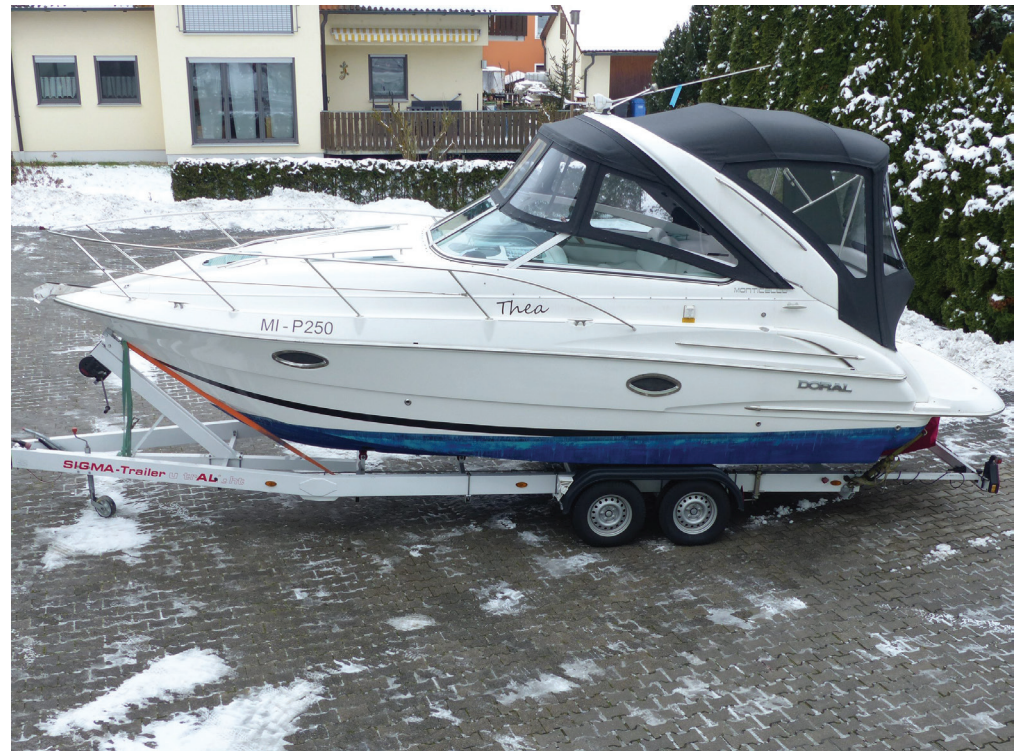
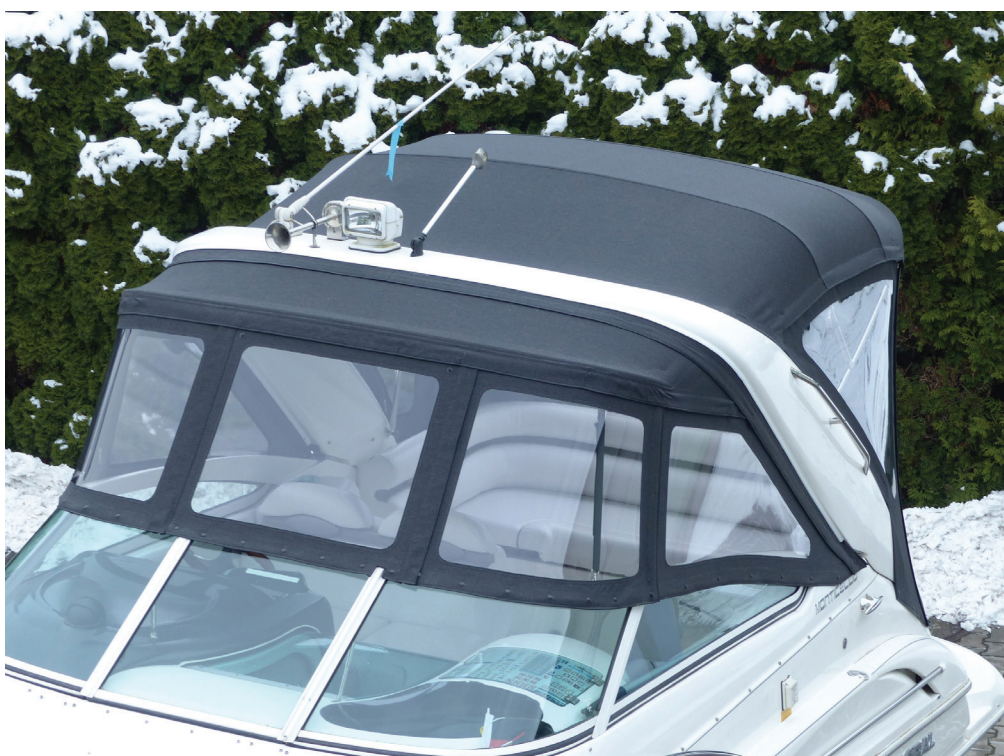
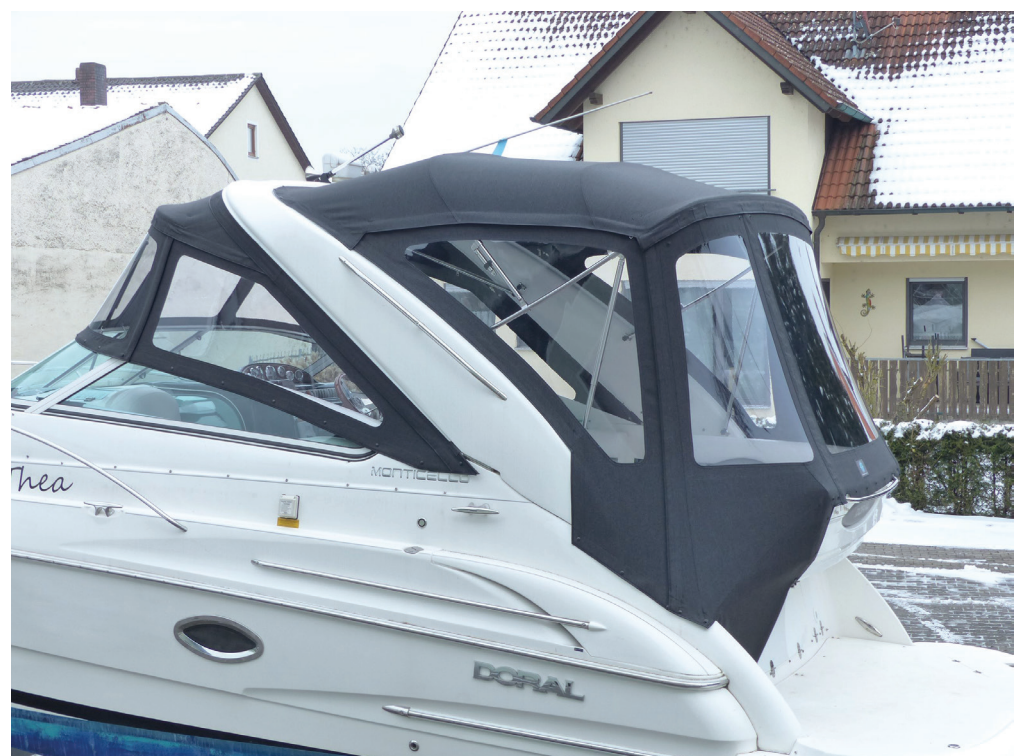
Doral 250SE—Bootssattlerei Hallier

The original enclosures supplied by Doral were not the worst on the market but far away from having a perfect fit and often they leak at the arch. Our customers wanted a perfect fit with absolute waterproofness.

Due to the design of the arch (wider than the original frames and windshield) and the design of the stern area (entrance and sticking out sitting area) the Doral 250 is one of the most challenging towable boats for an enclosure. Almost every panel including the two bimini tops have some hollow and 3D shape in it. Since we use normal 0.75mm roll clear the fit of every panel has to be perfect to get the windows as wrinklefree as possible. Especially the entrance panel is curved in every direction making it a real challenge to sew the window in a no longer laying flat canvas.
