Big V—SeaCanvas IIc

Powerboat - Soft Enclosures

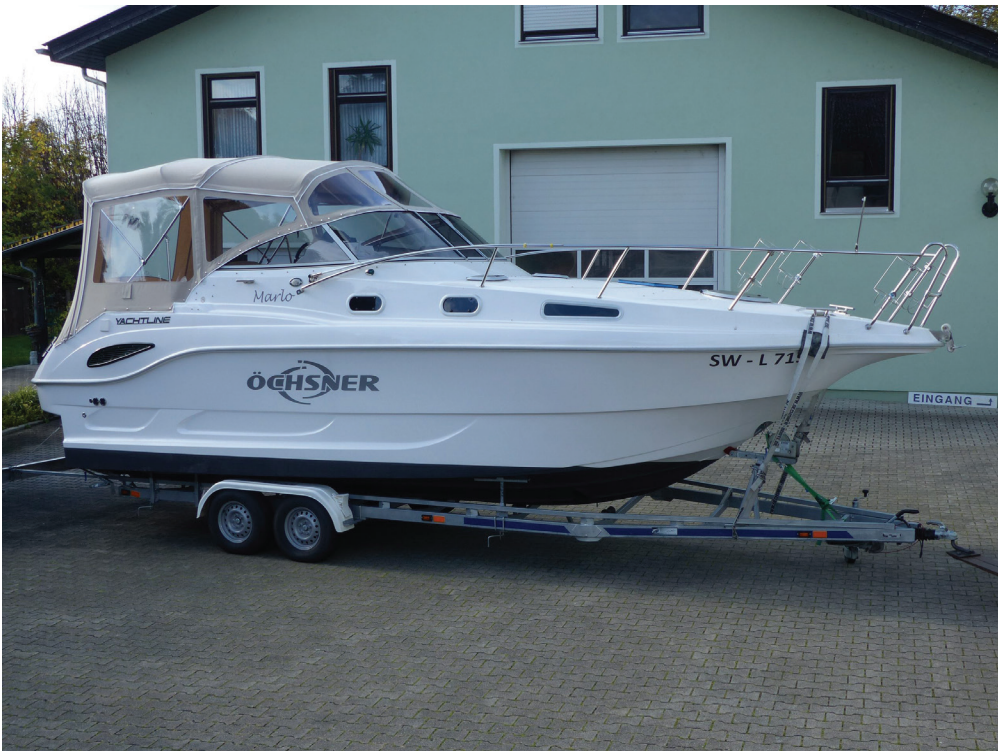
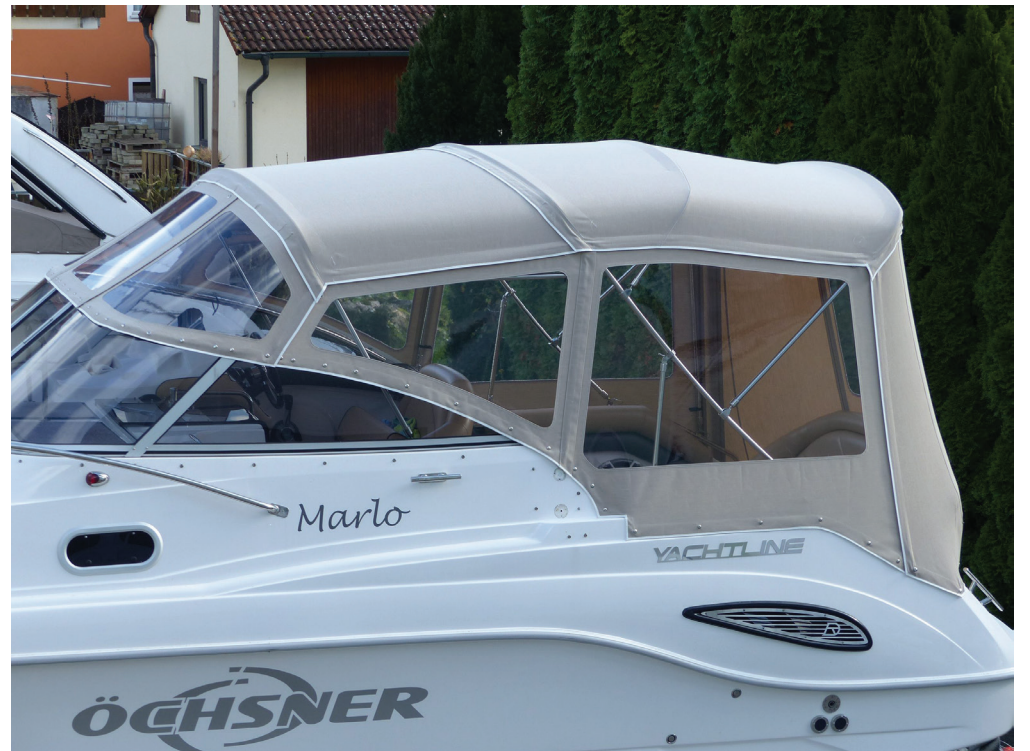
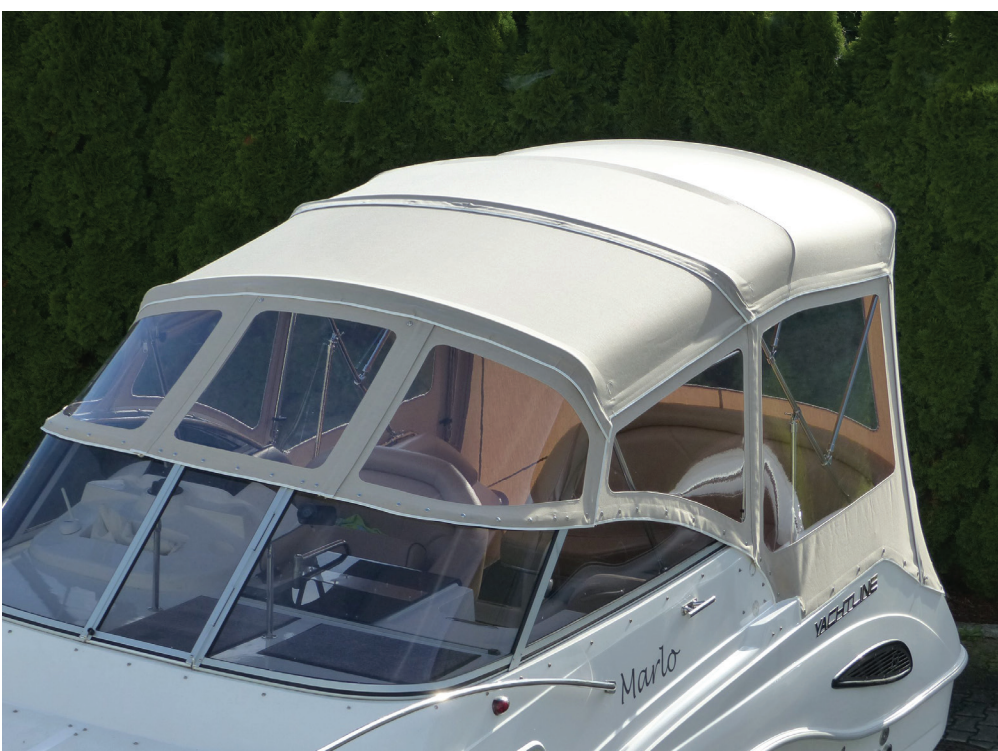
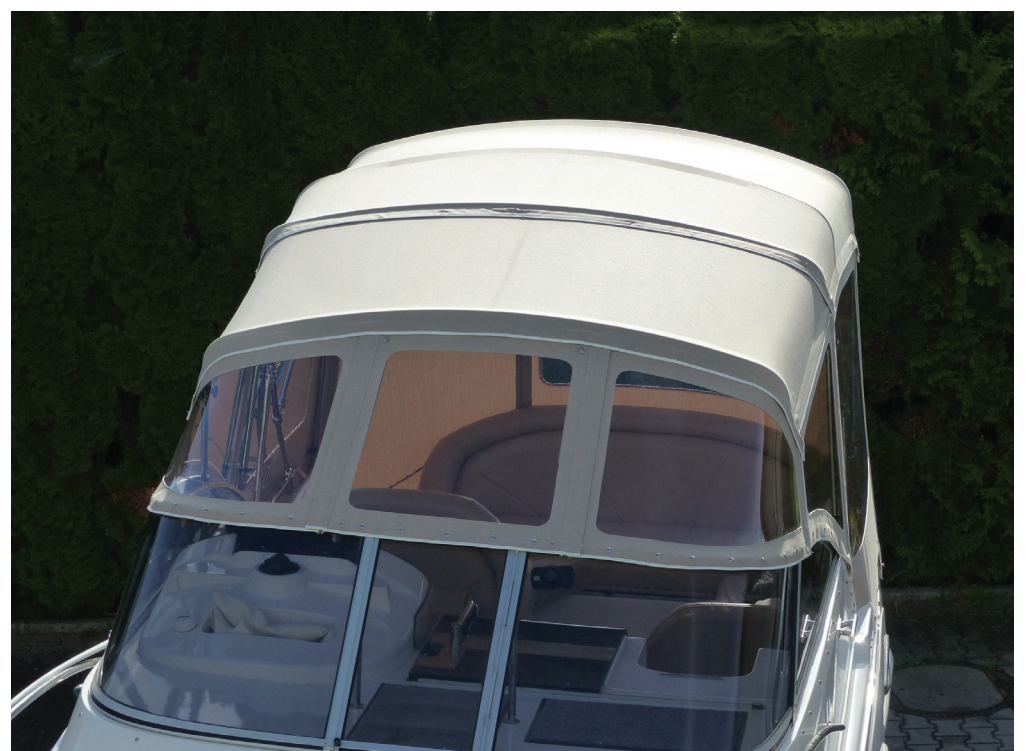
Drago 29 Yachtline—Bootssattlerei Hallier

After only one year of use our customers wished to get rid of the original enclosure and get one that fits much better, that is waterproof and that the frames can be easily folded over for trailering. In addition they wanted more headroom in the back/entrance.

In order to get the framework collapsible we had to turn the normal frame setup 180° around, having three frames in the back and one in the front. The single frame is also about 20cm more narrow than the other three due to the windshield. This frame setup offered much more space for the seating area in the back while allowing having the whole front part being tensioned right while not being wider than the windshield (making it harder to get the front top panel wrinklefree). Since the bench at the stern sticks out we switched for fastening the back panel from original snaps / LoXX to webbing.

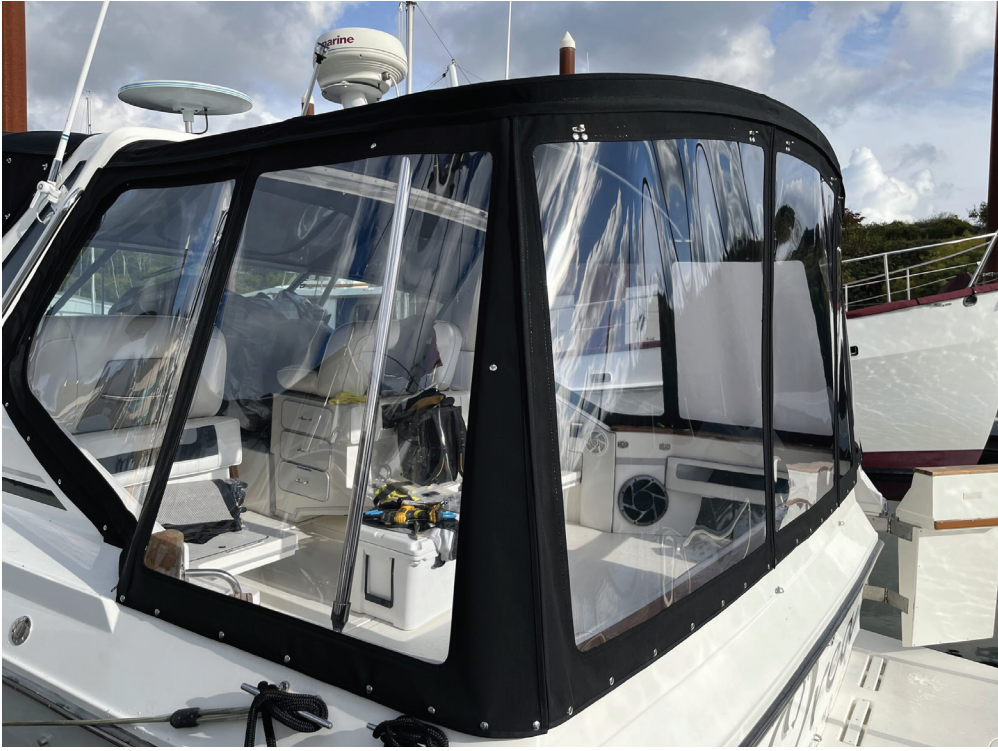
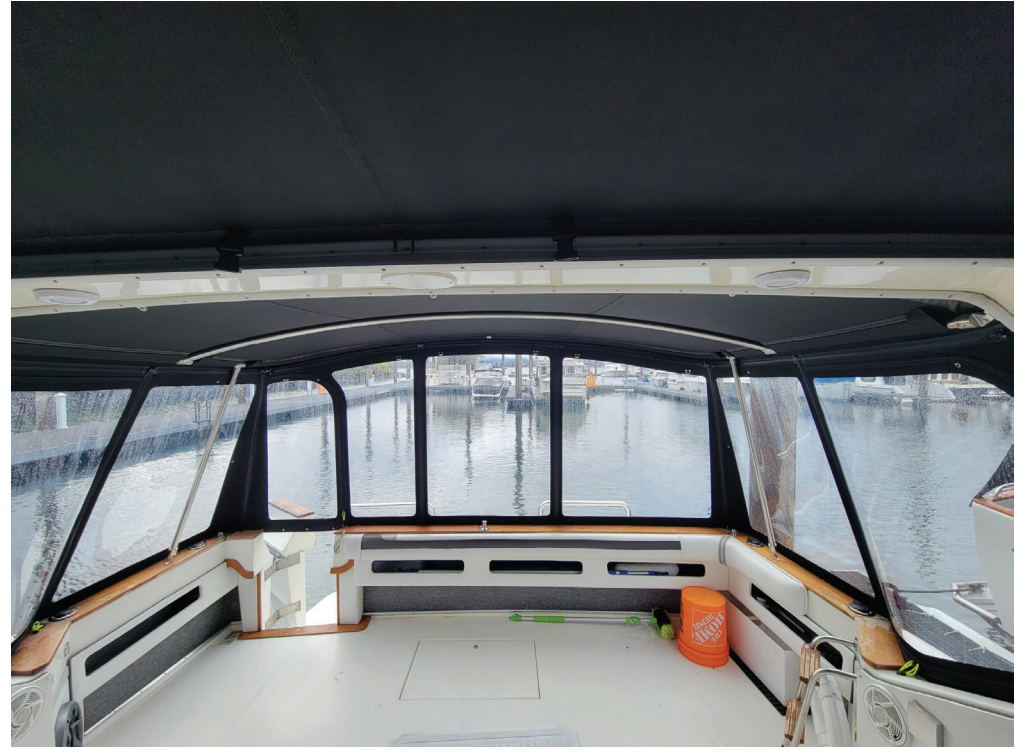
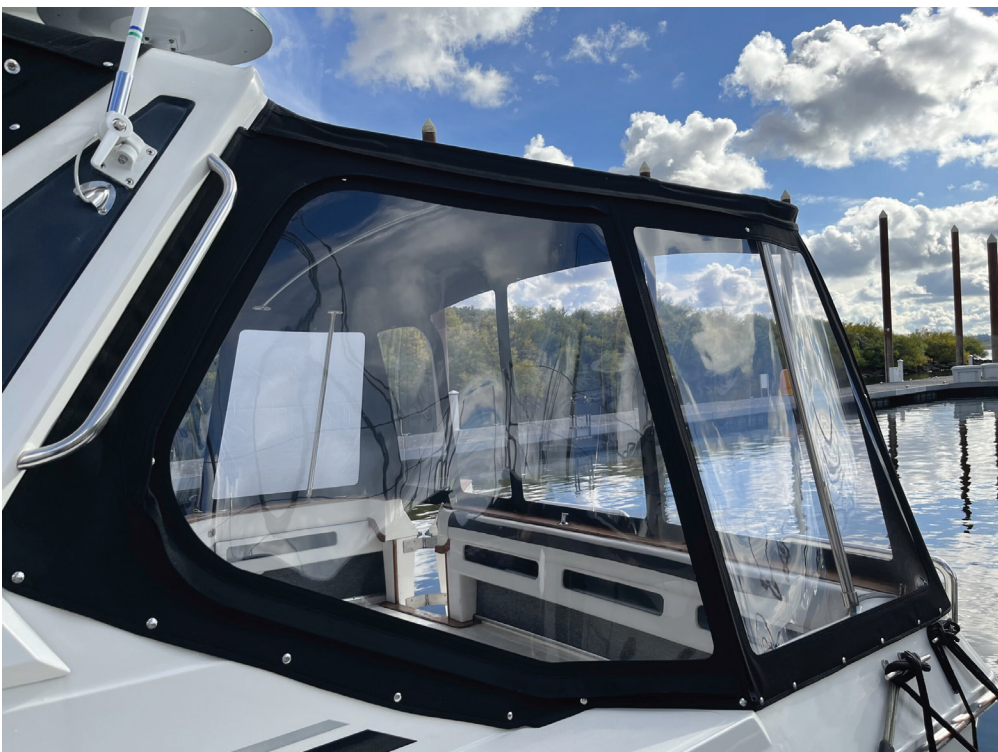
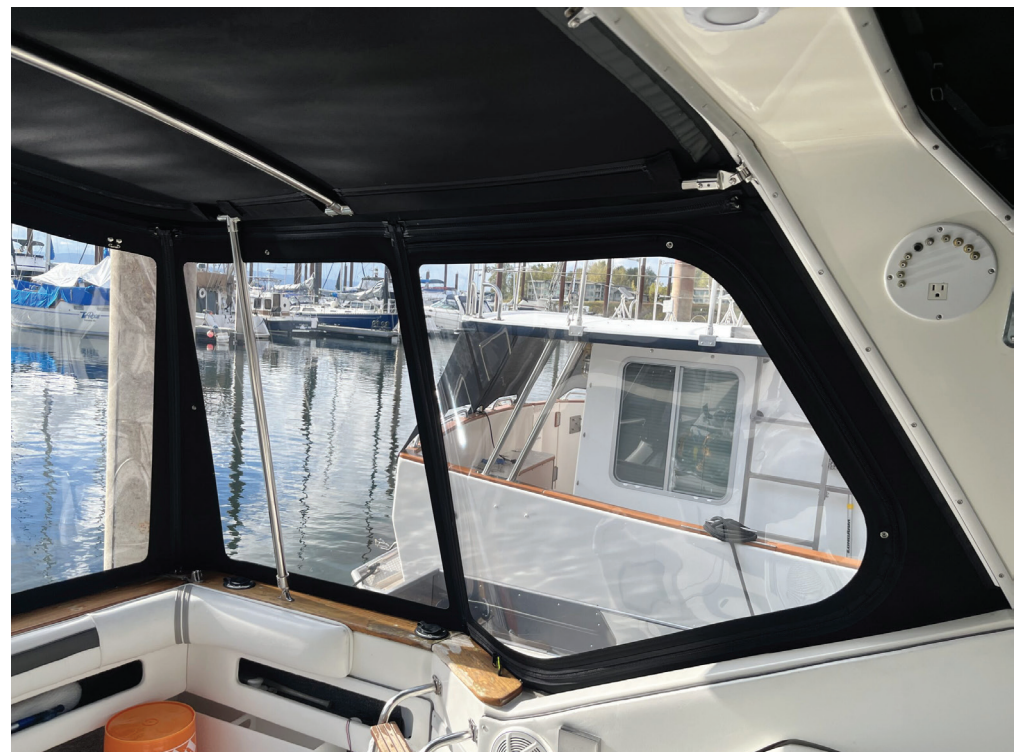
SeaRay 39 aft enclosure upgrade—Hayden Island Canvas

The customer wanted a new aft enclosure that didn't pool like the previous enclosure, and fit and looked better. The entryway to the boat needed to be easier and so did access to the bow. We fabricated a rigid horizontal frame off of the radar arch with sufficient crown for water runoff, along with a new canvas top and 7 panels with O'Sea clear vinyl. The aft entryway panel got an easy access zipper for folding the soft panel to the support stanchion of the top on the port side, along with fold back port and stb easy access zippers for forward access. Our high-vis zipper pulls are very easy to find against the black fabric.

This project shows off the craftsmanship we put into all of our powerboat enclosures along with some of the features we often use...Easy access zippers with high vis pulls, larger tubing, horizontal rigid tops, and top rated materials. The sheer width of the beam of this boat took some extra careful planning as one stick of stainless tubing would not be long enough to make the main bow. Splices were carefully hidden where the tee's for other parts of the frame go. The bow follows the aft crown of the transom, but also has enough crown to match the middle bow and provide sufficient runoff and strength. While we usually go for maximum clear in our panels, the square corner to radius transition would have put too much stress in the vinyl, and while it would look fine today we know that would be the first point to break in years to come, so extra fabric was placed here to avoid this and also to facilitate being able to zip up the panel at this point and access the cleats easier from inside the boat.
